## WEEKLY STATUS REPORT

BCP Project No.:	C224099	EPA Consent Order No.:	CERCLA-02-2017-2021	Date:	05/31/2019
Project Name:	BRT Powerhouse 153 2 <sup>nd</sup> Street AKA 322 3 <sup>rd</sup> Avenue, Brooklyn, NY 11215				
Remediation Activities (Week of May 27, 2019): <ul style="list-style-type: none"><li>Continued gauging and product recovery via absorbent sock as necessary.</li><li>Completed quarterly groundwater sampling from onsite monitoring wells.</li></ul>					
Redevelopment Activities (Week of May 27, 2019): <ul style="list-style-type: none"><li>Completed steel repair work on the third and fourth floors of the turbine hall.</li><li>Continued general site maintenance and removing debris from site roadways.</li><li>Continued demolition and clean-up on the ground, first, and second floors of the turbine hall. Assorted demolition debris was removed from the site as it was generated.</li><li>Continued unloading the 0-50% interval of the boiler house load test and stockpiling the soil on the west side of the site. All soil was inspected for signs of impact (staining, odor, photoionization detector [PID] readings). All soil with signs of impact (staining and/or odor) were stockpile

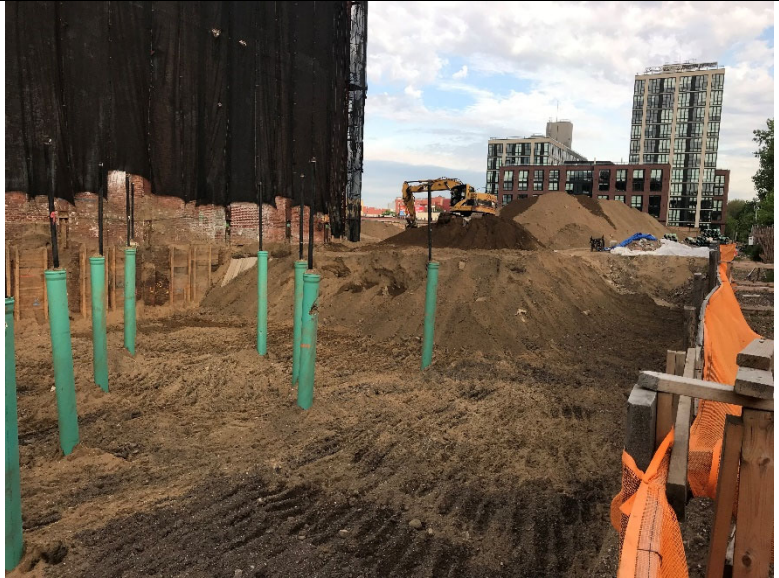
Photo 1 – Looking west at the boiler house load test. Darcon continues to remove 0-50% interval soil from the boiler house load test.

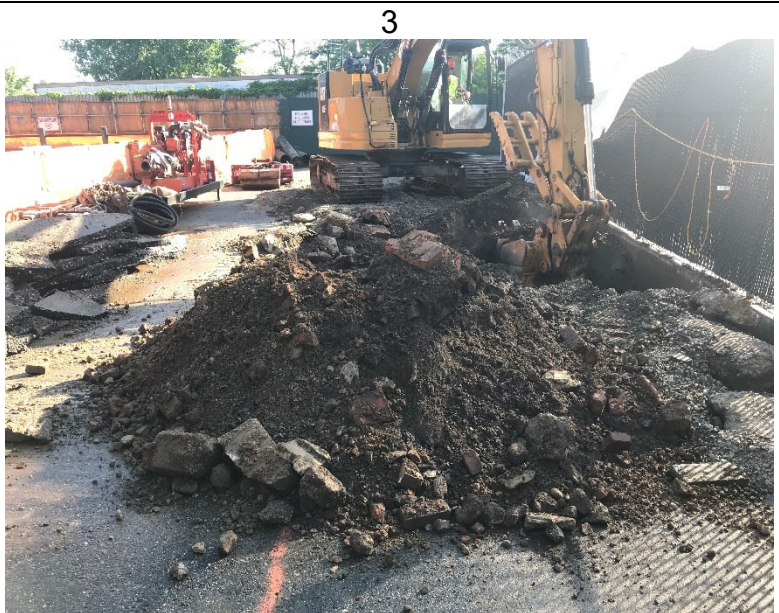
Photo 2 – Looking north in the east site driveway. Structure Tech excavates to investigate and measure the ACM conduit banks.

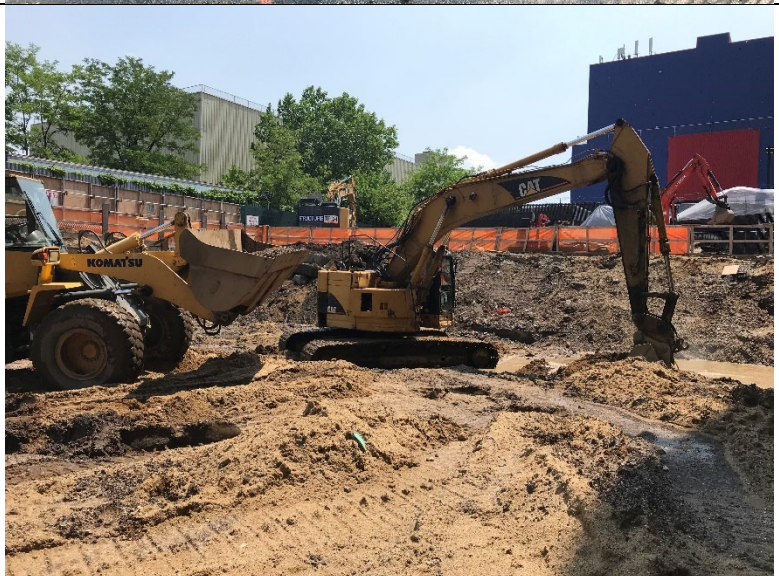
Photo 3 – Looking northeast at the boiler house slab. Darcon begins removing the 1 ft buffer interval soil from the boiler house slab.
